# Sem analysis of working surface in new manual endodontic instruments

**Introduction** The aim of this study was to analyze working surfaces of new hand endodontic instruments and to check possible existence of dirt or defects on working surface that resulted from manufacturing process using SEM.

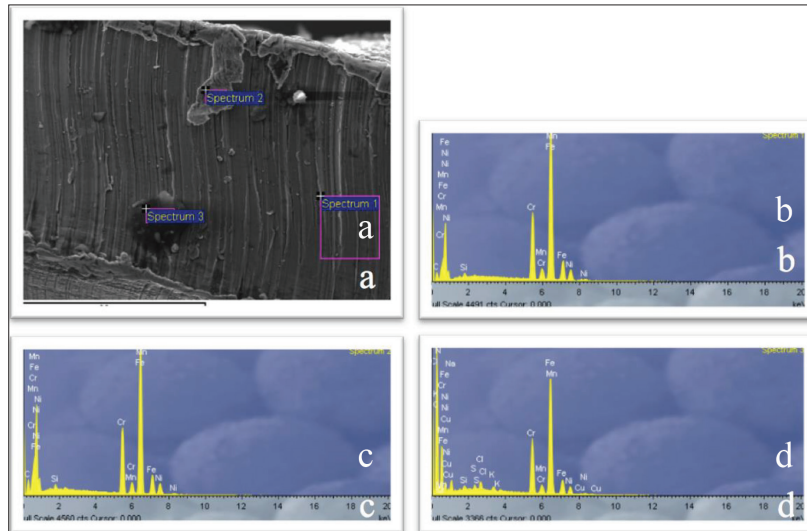
**Figure 1.** EDS analysis of KF instruments (ISO 20): a) SE image with marked points which were analyzed (Spectrum 1–3); b) Diagram of EDS analysis Spectrum 1; c) Diagram of EDS analysis Spectrum 2; d) Diagram of EDS analysis Spectrum 3**Slika 1.** EDS analiza instrumenta KF (ISO 20): a) SE snimak sa obeleženim tačkama u kojima su rađene analize (Spektrum 1–3); b) Dijagram EDS analize Spektar 1; c) Dijagram EDS analize Spektar 2; d) Dijagram EDS analize Spektar 3

EDS analysis of KF instrument (ISO 20) (Figure 1, Table 1) for Spectrum 1 was performed on a clean part of

instrument surface, while Spectrums 2 and 3 were performed on a contaminated surface. The most abundant element in the analysis of Spectrums 1 and 2 was iron with maximum abundance of 65.93 mas%. Apart from carbon (maximum 11.03 mas%), there were also silicon,

chrome, manganese and nickel in different mass concentration. Analysis of Spectrum 2 indicates contamination with metal strips. Carbon (34.71 mas%) and iron (31.19 mas%) were the most abundant elements in Spectrum 3. Oxygen was also detected (13.45 mas%) as well as chrome, nitrogen, nickel, sodium, chlorine, copper, potassium and sulfur but to a lesser extent. Results from Spectrum 3 show contamination with organic debris.

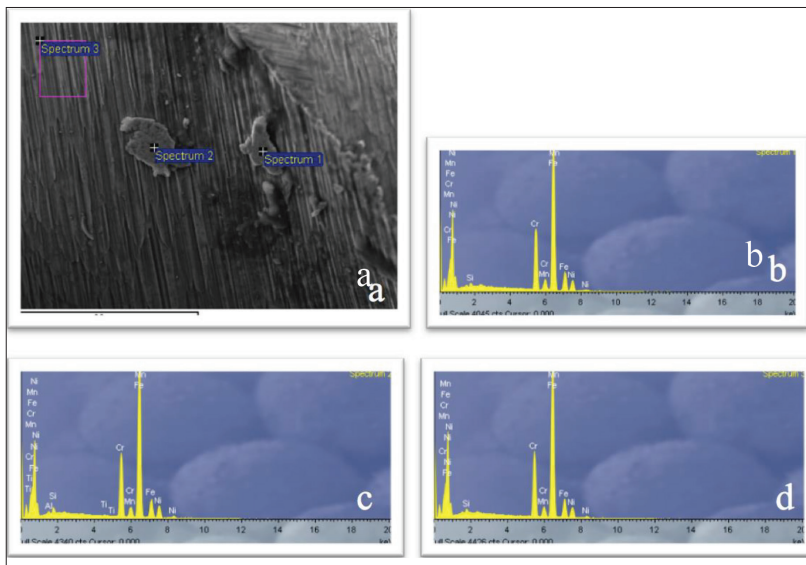
**Figure 2.** EDS analysis of HF instrument (ISO 25): a) SE image with marked points which were analyzed (Spectrum 1–3); b) Diagram of EDS analysis Spectrum 1; c) Diagram of EDS analysis Spectrum 2; d) Diagram of EDS analysis Spectrum 3

EDS analysis of HF instrument (ISO 25) (Picture 2, Table 2) for Spectrum 1 was performed on a clean part of instrument surface, while Spectrum 2 and 3 were performed on a contaminated surface. The most abundant element in the analysis of all three Spectrums was iron with maximum presence of 71.12 mas% and minimum of 69.53 mas%. Aluminum, silicon, titanium, chrome, manganese and nickel were detected in different mass concentrations. EDS analysis of Spectrums 2 and 3 showed contamination with metal strips.

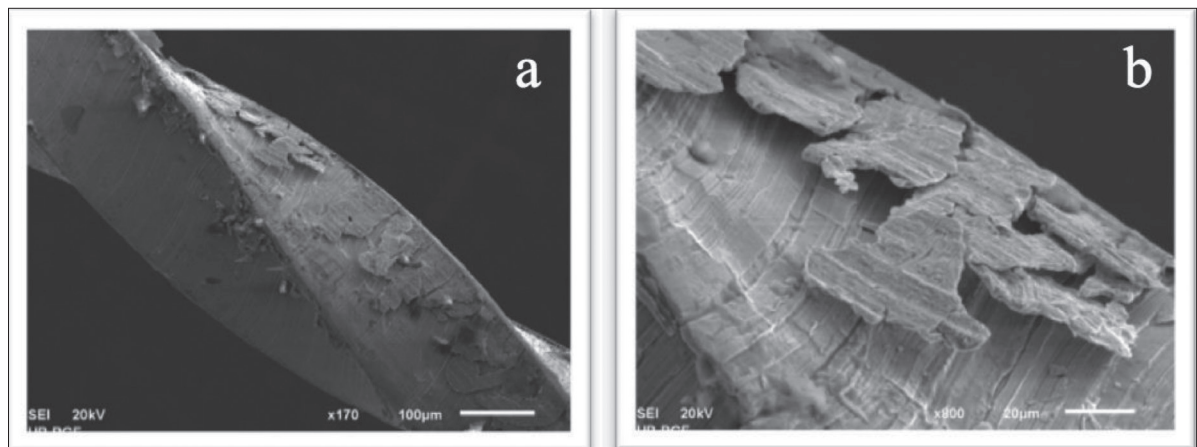
**Figure 3.** SEM analysis of working surface (middle third) of KF instruments with metal strips and fretting: a) magnification 170 $\times$ , b) magnification 800 $\times$ **Slika 3.** SEM analiza radnog dela (srednja trećina) instrumenta KF sa metalnim opiljcima i žljebovima: a) uvećanje 170 $\times$ , b) uvećanje 800 $\times$

Fretting on working surface of an instrument during the manufacturing process was noticed in all tested hand stainless steel instruments. Conventional manufacture of instruments by twisting the wire (of quadrangular profile for K-type file and milling of circular profile for Hedstrom file) causes surface irregularities such as traces of milling and metal flash (especially on blades) which might compromise efficiency of instrument blade and potentially cause problems related to corrosion and fracture [20, 25, 26]. Clinical importance of fretting on instrument surface reflects in its easy screwing (due to friction that is present because of uneven surface) which as a consequence leads to greater incidence of fracture [27]. Greater incidence of HF file fracture is explained with different design of this file which implies different activation in root canal. HF instruments have increased incline of blades compared to the instrument axis (60° and 65°) while KF has significantly smaller angle (25° and 40°), therefore, manipulation must be very careful [28].

Presence of metal strips, shown in all tested groups in 100 percent, just confirms the complexity of endodontic instrument manufacture. This finding complies with the result of Chianella et al. study that confirmed the presence of such contamination in 96.3% of all new tested instruments [28]. This type of defect is very significant since it decreases the blade efficacy. Apart from that, metal strips on

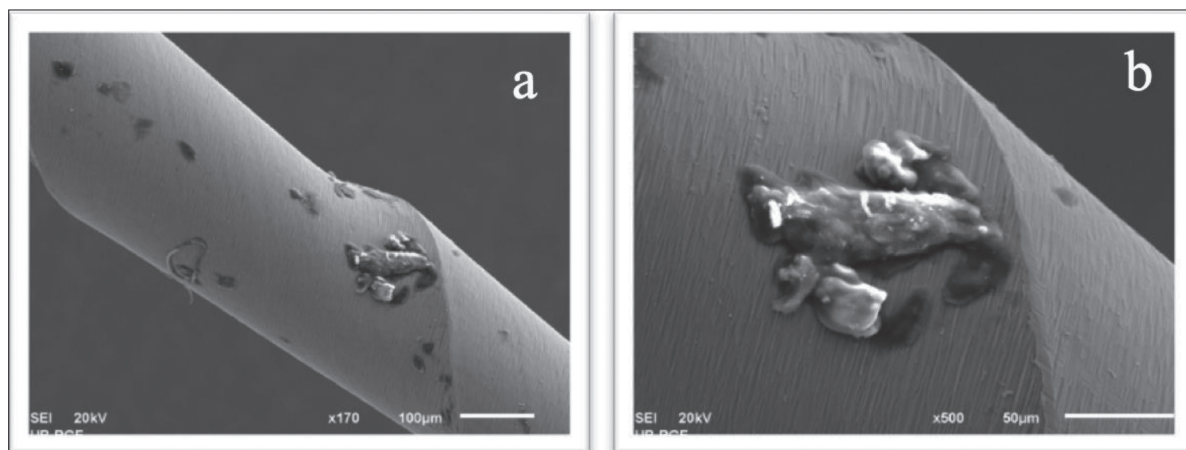
Debris was noticed on all KF instruments (100% apical and middle third) and half of the HF instruments (56% apical and middle third) (Table 3, Graph 1, Figure 4 and 5). After the comparison of debris on different hand instruments (KF and HF), statistically significant difference was noted ( $p = 0.0029$  in apical and  $p = 0.0029$  in middle third).

**Figure 4.** SEM of middle third of KF 20 instrument with debris: a) magnification 170x, b) magnification 500x

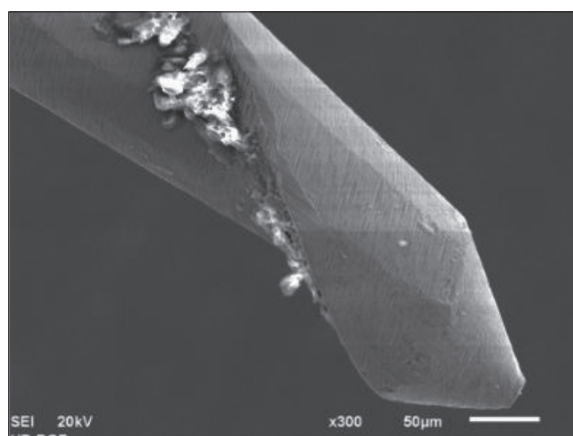
**Figure 5.** SEM of apical third of KF 25 instrument with debris (magnification 300x)

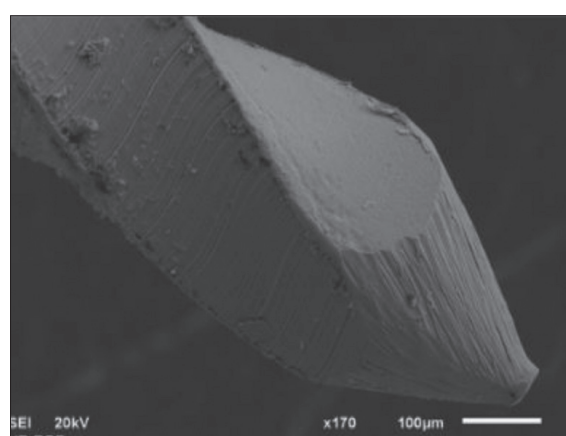
middle third) and HF instruments (11% apical and 6% middle third) (Tables 3, 4, 5, Graph 2, Picture 6). After the comparison of pitting on different hand instruments (KF and HF), both apical and middle thirds showed statistically significant difference ( $p = 0.0051$  end) ( $p = 0.0045$  middle).

**Figure 6.** SEM of apical third of HF 35 instrument with pitting

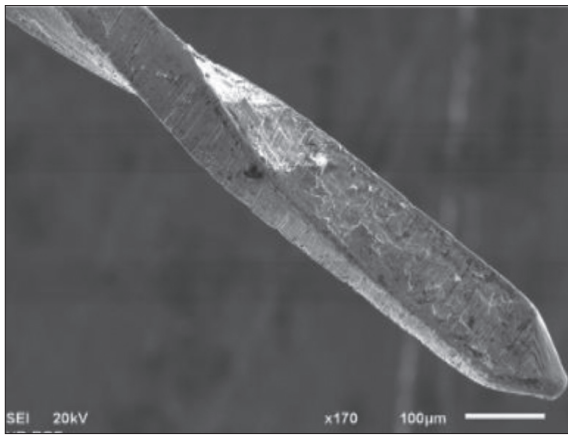
Metal flash, corrosion of working surface and disruption of cutting edge were detected only in KF instruments (corrosion 11% apical and 17% in middle third; metal flash surface 11% apical, 6% in middle third; disruption of cutting edge 2% apical) (Table 3, 4, 5, Figures 7 and 8).

**Figure 7.** SEM of apical third in KF15 instrument with metal flash and disruption of cutting edge

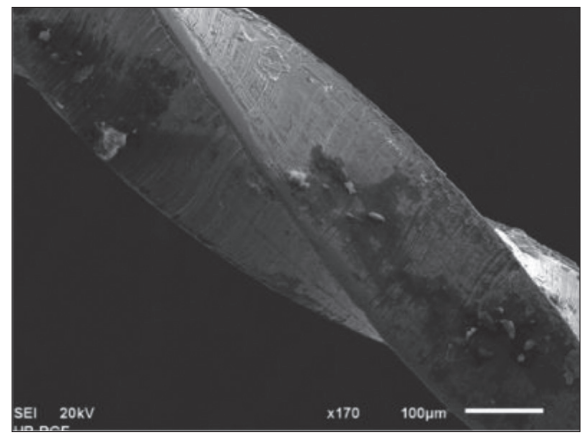
**Figure 8.** SEM of middle third of KF 25 instrument with corrosion
