Evaluation of surface characteristics of new rotary nickel-titanium instruments – SEM-EDS analysis

Milica Jovanović Medojević¹, Alena Zdravković², Mina Medojević¹, Đorđe Stratimirović¹

¹University of Belgrade, School of Dental Medicine, Belgrade, Serbia;

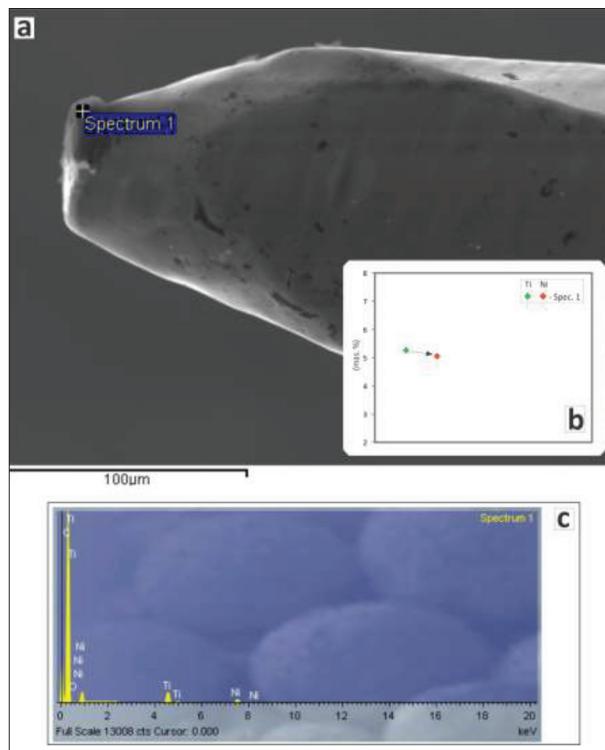
SEM-EDS analysis in point 1 (spectrum 1, Figure 1, Table 2) shows that dominant element in the examined sample was carbon (88.1 wt%) with low oxygen content (1.5 wt%), and impurity on this ProTaper Universal instrument is characterized as a debris of organic origin. Nickel and titanium contents (spectrum 1) reflect the composition of instrument.

Figure 1. SEM-EDS analysis of the new ProTaper (Sx) instrument
a) SE image of the tip of ProTaper (Sx) instrument with the marked point where EDS analysis was performed, parts of its surface, b) nickel and titanium contents (wt%), c) spectrum of the analysed point
Slika 1. SEM-EDS analiza površine novog ProTaper (Sx) instrumenta
a) SE snimak vrha ProTaper (Sx) instrumenta sa označenom tačkom u kojoj je izvršena EDS analiza, dela njegove površine,
b) sadržaji nikla i titanijuma (mas %),
c) izgled spektra 1 za analizu u tački 1 (a)

Table 2. EDS analysis of the sample of ProTaper Universal (Sx) instrument in point 1 (Figure 1)

Spectrum	C	O	Ti	Ni	Total Ukupno
Spectrum 1	88.1	1.5	5.3	5.1	100.0

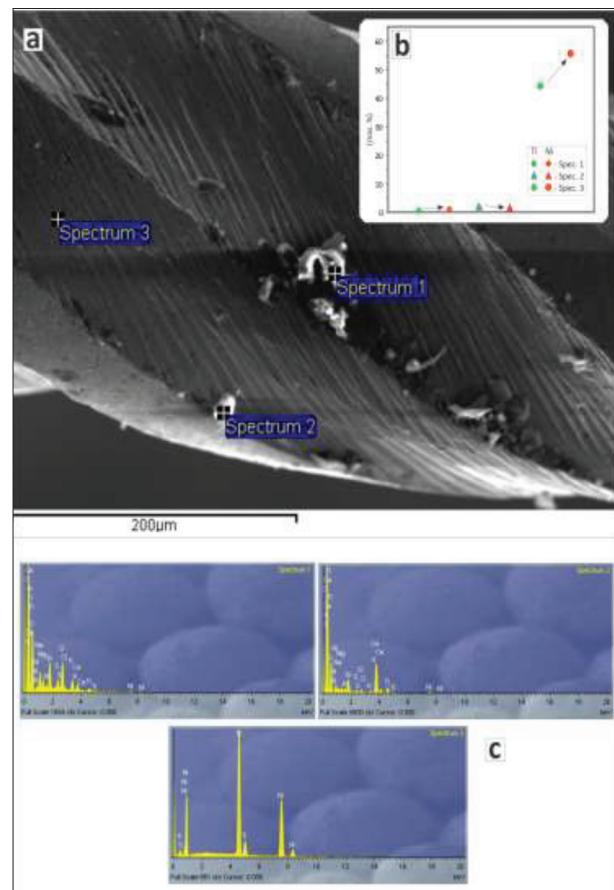
Based on SEM-EDS analysis, the impurities on K3 instrument are characterized as a combination of debris of organic origin and contamination with metal strips. The quantity of nickel and titanium in analysis 1 (spectrum 1, Figure 2) and slightly more quantity of these two elements in analysis 2 (spectrum 2, Figure 2) represents the distribution of these elements in the structure of instruments, just like in the previous case.

Table 3. EDS analysis of sample K3 (25-0.10) in points 1–3 (Figure 2)

Spectrum	C	O	Na	Mg	Al	Si	S	Cl	K	Ca	Ti	Ni	Total Ukupno
Spectrum 1	47.6	37.4	2.3	1.0	0.2	2.5	1.0	3.6	1.6	1.1	0.6	1.1	100.0
Spectrum 2	49.8	34.0	0.8	0.6	0.4	1.8	0.3	0.5	0.4	7.7	2.0	1.7	100.0
Spectrum 3	0.0	0.0	0.0	0.0	0.0	0.0	0.0	0.0	0.0	44.3	55.7	100.0

Figure 2. SEM-EDS analysis of a new K3 (25-0.10) instrument
a) SE image of K3 instrument surface with marked points where EDS analyzes were performed, b) nickel and titanium contents (wt%) at the analysed points (spectra 1–3),
c) spectrums of the analysed points 1–3

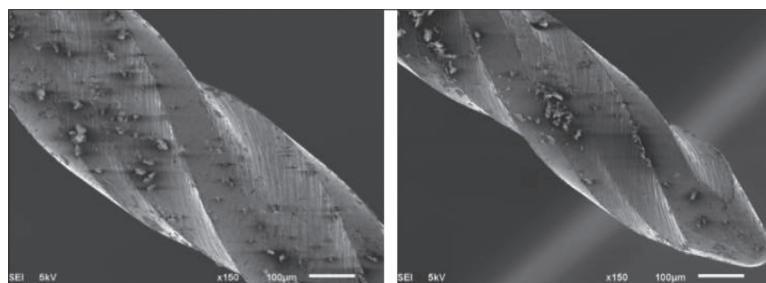
The presence of pitting and fritting (apical and middle third 100%), the presence of defects in the form of metal strips (apical third 83.33%, middle third 38.89%) and

corrosion on only one instrument (apical and middle third) (Figure 3) were noticed on the surface of working part of new K3 instruments. Debris was observed in apical third in 77.8% of instruments and in middle third in 44.44% of K3 instruments.

Figure 3. SE image of new K3 instruments: a) surface of middle third (25/0.10) with defects in the form of metal strips, pitting and fretting ($\times 150$) b) surface of apical third (25/0.08) where defects in the form of metal strips, pitting and fretting can be observed ($\times 150$).

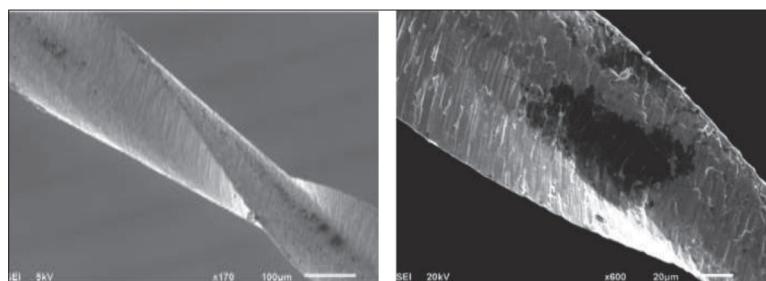
SEM analysis of Mtwo instruments indicated the presence of metal strips in apical (50%) and middle third (22.2%). The corrosion was observed only on one instrument (the thinnest one) (10 / 0.4) in its middle third (Figure 4).

Figure 4. SE image of new Mtwo instrument: a) surface of middle third (10/0.4) with the presence of corrosion ($\times 170$); b) detail from the previous image at higher magnification ($\times 600$).

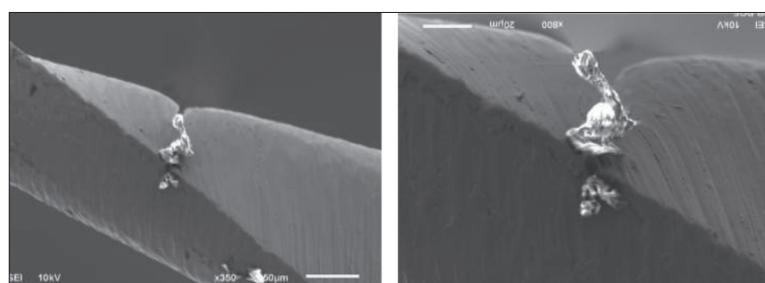
Blunt cutting edge of Mtwo instruments was observed on apical surface of one instrument (25 / 0.6) and defect in the form of disruption of cutting edge in middle third of

the instrument (20 / 0.6) (Figure 5). Debris (confirmed by EDS analysis) was observed on all instruments, both in the apical and middle third (100%).

Figure 5. SE image of new Mtwo instrument (20/0.6): a) area of middle third with a disruption of cutting edge defect ($\times 350$); b) detail from the previous image at higher magnification ($\times 800$)

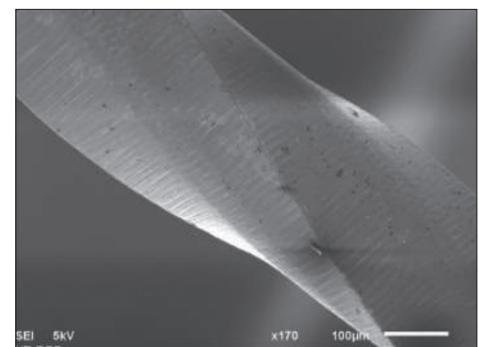
The most common defects on the working surface of new ProTaper Universal instruments were changes in the form of fretting (apical and middle third, 100%) and pitting (apical third 83.3% and middle third 88.8%) (Table 4, Figure 6). Metal strips were detected on the apical (50%) and middle third (38.8%). A defect on the cutting edge (disruption of its continuity) was observed on one, the most conical instrument (Sx) (apical and middle third), and corrosion on the apical (11.1%) and middle part (11.1%) (Figure 7). Contamination in the form of debris was noticed in apical third (100%) and in middle third of slightly more than a half (55.5%) of ProTaper Universal sets. The most common defects on new HyFlex instruments were the appearance of fretting in the form of debris on apical and middle segments of all instruments (100%) (Figure 8). A defect in the form of a microfracture was observed on the apical part of the instrument (25-0.08) as well as the appearance of metal strips (25-0.04).

Figure 6. SE image of middle part of ProTaper Universal instrument (F2) with pitting and fretting ($\times 170$)

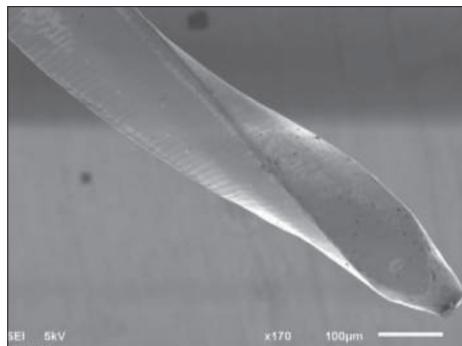
Figure 7. SE image of apical third of new ProTaper instrument (Sx) with corrosion and discontinuity of cutting edge (apart from the presence of pitting and fretting) ($\times 170$)

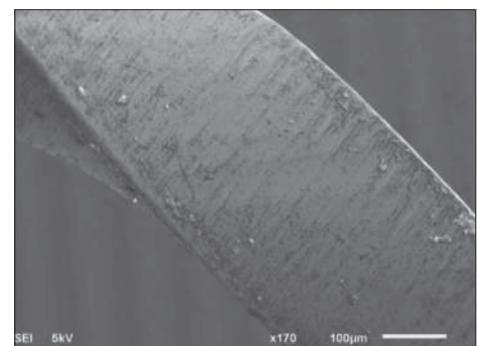
Figure 8. SE image of the middle third surface new HyFlex instrument (30-0.04) with the presence of fretting and debris ($\times 170$)

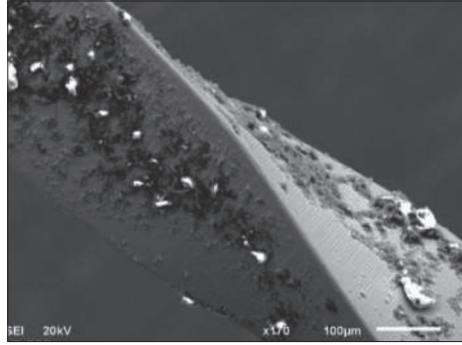
The results of SEM analysis of BioRaCe sets show the most frequent occurrence of metal strips (apical 50% and middle third

Figure 9. SE image of the surface of new BioRaCe instrument (No. 3) i.e. its middle third with the presence of metal strips and fretting ($\times 170$)

38.8%) and fretting (apical 33.3% and middle third 27.7%) (Table 4, Figure 9). Debris contamination detected by EDS analysis was observed on the apical (11.1%) and middle surface (22.2%) of the instruments.
