SEM analysis of Mtwo instruments after instrumentation of root canals with different curvatures

Milica Jovanović Medojević¹, Ivana Milanović¹, Alena Zdravković², Đorđe Stratimirović¹

¹University of Belgrade, School of Dental Medicine, Belgrade, Serbia;

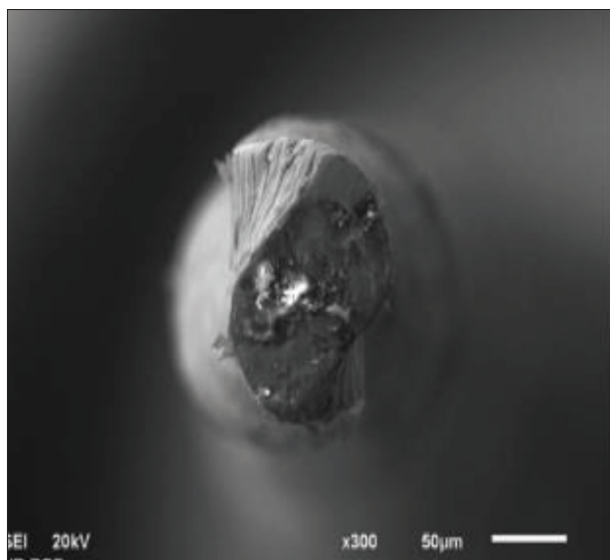
**Figure 2.** SE image of Mtwo 10/0.04 instrument with complete fracture (fractographic image at magnification $\times 300$) which shows the difference in the appearance of the fracture surface in the central and peripheral area.

middle third); two instruments in the second group (10/.04 and 25/.06) (apical and middle third) and one instrument in the middle third (20/.06); while in the third group the defect was registered in the middle third of one instrument (15/.05) (Table 3). Along with corrosion, dullness, rupture of the cutting edges, the appearance of microfractures was also observed. Blunted blade edge was observed in the apical third of the thinnest (10/.04) instrument in the first group (the same instrument which showed corrosion), in the apical third (25/.06) of the instrument in the second group and in the middle third of the instrument (25/.06) of the third group. The interrupted cutting edge was noted in the apical third of the smallest instrument (10/.04) in the second group and in the middle third of one instrument (25/.06) in the third group. Microfracture was observed in the apical third of the instrument (15/.05) in the first group and in the apical third of two instruments in the third group, (10/.04 and 15/.05). Complete fractures were recorded on the same instruments in the third group (10/.04 and 15/.05). The fracture of instrument 10/.04 occurred after nine uses (length of the fractured fragment 1.5 mm) and after the eighth use of instrument 15/.05 (fragment of 0.8 mm) (Table 3, Figure 2, 3).

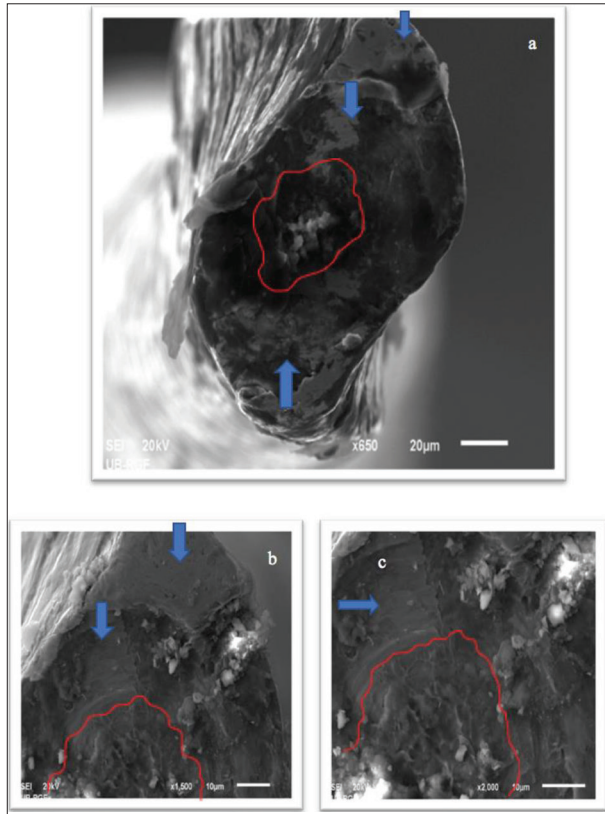
Fractographic micrographs (Figure 3) under $1500\times$ and $2000\times$ magnifications showed the central zones of the fracture surface with microscopic holes (which is an indicator of torsional changes) and clear traces of circular abrasion on its outer parts. Another defect was the appearance of a thread change and twisting (present only after preparation of curved (25% apical and middle third) and extremely curved canals (50% apical and 25% middle third) (Table 1). This change was observed in the second experimental group on two instruments (in the apical third of the instrument (10/.04) and in the middle third of the instrument (20/.06)), and on three instruments in the third group, (in the apical third of the instruments

Figure 3. SE images of Mtwo 10/0.04 instrument with complete fracture:

a) fracture surface ($\times 650$) on which central zones with microscopic holes (marked with a red field) and circular traces of abrasion on the outer parts of the fracture surface (marked with blue arrows) are clearly visible; b) detail from Figure 3a at higher magnification ($\times 1500$) and c) detail from Figure 3a at higher magnification ($\times 2000$)

Two fractures of Mtwo instruments in the third experimental group confirmed torsional stress as the cause. On the SEM images of the cross section of the fractured instrument (10/0.04), the central zones with microscopic holes that indicate torsional changes are clearly visible. In the study of Inan and Gonulol, longitudinal micrographs of the same instrument showed thread changes (straightening and unwinding of the thread) with numerous microfractures on the surface of the fractured instrument [14]. The same finding was observed on the fracture surface Mtwo (15/0.05) of the instrument where the fracture site coincides with the position of maximum bending

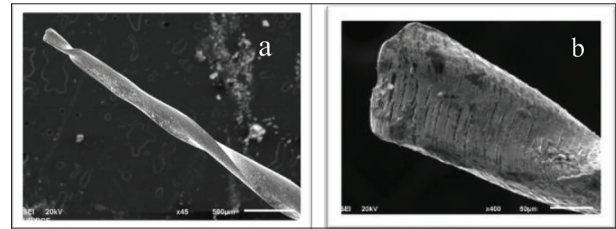
SEM images (Figure 4) showed longitudinal image of a fractured Mtwo instrument (15/0.05), thread changes (thread straightening and unwinding) with an abundance of microfractures on the surface of the fractured instrument, especially in the immediate vicinity of the fracture. The same finding was observed on the fracture surface of the Mtwo 15/0.05 instrument (Figure 7). The occurrence of thread change deformation in bent and extremely bent canals shows a statistically significant difference in relation to the group with straight canals ($p < 0,05$).

Figure 4. SE recordings of Mtwo instrument 15/0.05 (longitudinal recording):

a) $\times 45$ magnification showing thread changes (thread straightening and unwinding) and complete apical segment fracture; b) longitudinal SE image of the apical fracture ($\times 400$) on which a multitude of microfractures were observed on the surface of the fractured instrument.

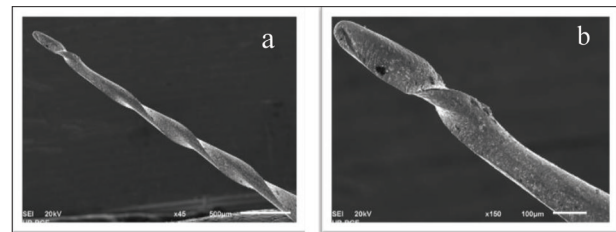
Figure 5. SE images: a) Mtwo instrument (10/0.04 of the second group at magnification $\times 45$) on which changes in the thread (unscrewing, straightening) are observed; b) the apical segment of the Mtwo instrument (10/0.04 of the second group at magnification $\times 150$) on which changes in the thread (unscrewing, straightening) are observed;

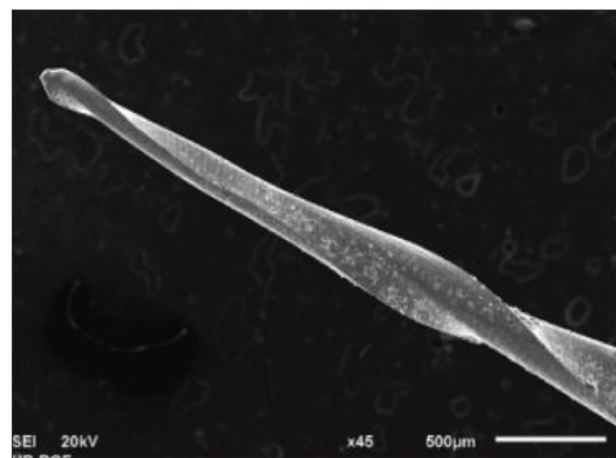
Figure 6. SE image of the apical segment of the Mtwo instrument (20/0.06 of the third group at magnification $\times 45$) on which the straightening of the thread is observed

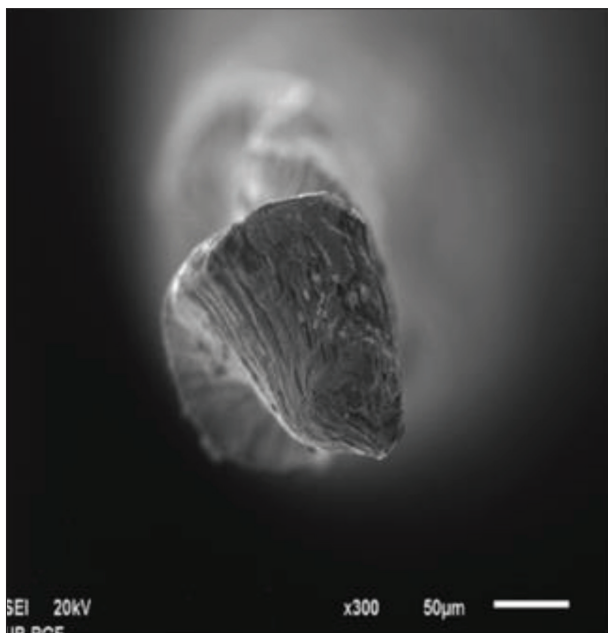
Figure 7. SE image of the fracture surface of the Mtwo instrument 15/0.05 at magnification $\times 300$, which shows a multitude of microfractures
