Possible Errors During the Optical Impression Procedure

Aleksandar Todorović¹, Dejan Lisjak², Vojkan Lazić¹, Aleksandra Špadijer-Gostović¹

¹Clinic for Prosthetic Dentistry, School of Dentistry, University of Belgrade, Belgrade, Serbia

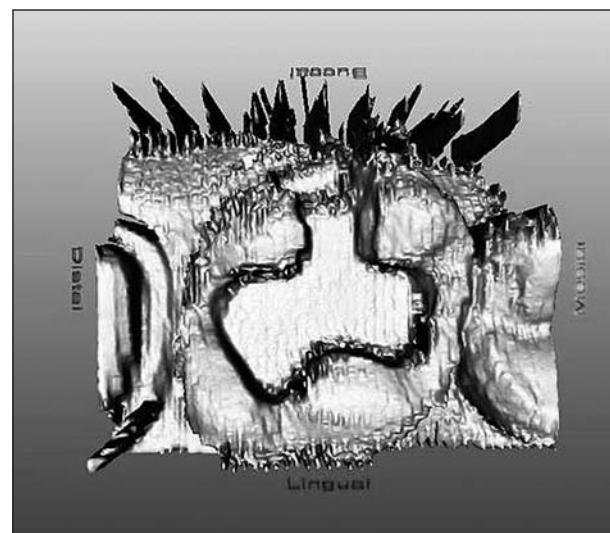
To get correct and applicable optical impression for further image processing procedure, therapist's hand holding the camera positioned in the mouth of the patient has to be steady long enough [5]. This type of error (Figure 1) is recognized as blurred, unclear and "corrugated" surface of the object while edges looks cut. In practice, safety is achieved by exercising on the model and with relaxed therapist's hand. Untrained therapist is advised to keep breathing at the time of scanning. For intraoral scanning Cerec® 3D CAD-CAM system uses a method of parallel beam [6]. This method allows the user to position the camera over the teeth at different heights and it is a great advantage when the camera is hand held. Another advantage of this system is rapid processing of data for calculating and designing 3D models. This is achieved by hardware calculating multiple exposures, where necessary calculations are done within fractions of seconds [7]. Knowing that the human hand can be steady without movement only 0.5 seconds, after which it takes a few seconds to rest, a therapist should have a stable support with the front part of the scanner (preferably on the mesial half on the occlusal surface of the distal agonist) [8]. This type of error is avoided in the new generation of Cerec® AC. A new, so-called "Blue cam" camera, besides using ultra-violet light while scanning, has increased resolution and full automation of collecting digital data. In addition to the shortening time, it accelerates and facilitates the scanning procedure itself and significantly affects the accuracy of virtual model.

Figure 1. Scanned first molar with destabilized scanner.
Slika 1. Skening prvog molara kao posledica velike nestabilnosti skenera tokom rada.

Da bi optički otisak bio ispravan i primenljiv za dalji postupak obrade slike, potrebno je da ruka terapeuta koja drži kameru pozicionirana u ustima pacijenta bude dovoljno dugog mirna [5]. Ova vrsta greške (Slika 1) je tipična po nejasnoj,

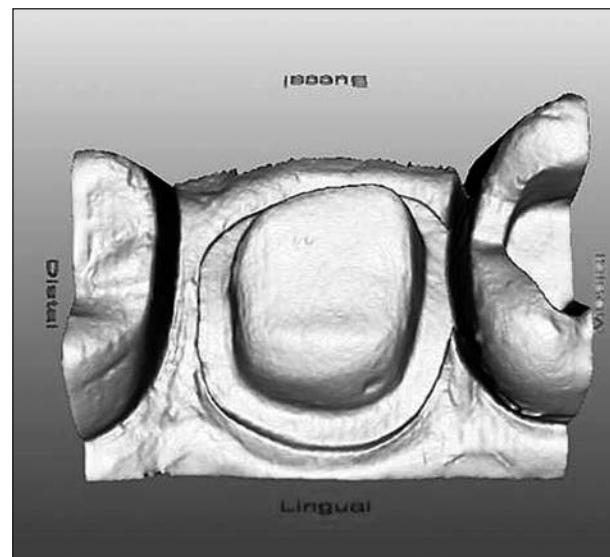
The ideal position of the scanner to the object of scanning is that angle of the scanner in mesio-distal direction is 30 degrees in relation to the distal point. In bucco-oral direction, the optimal angle is 90 degrees to the scanning object, which should be projected in the center of the camera lens. In occluso-gingival direction, the distance of the most gingival point of the scanned object and the scanner lens should not be larger than 15 mm. Larger deviations from these values lead to inappropriate forms of virtual models, irregular areas and incorrect dimensions of dental restorations and therefore the wrong mathematical calculations of the central module (Figure 2). This kind of error is not difficult to recognize because certain parts of the image are in the shadow or covered by surrounding structures. Errors in the vertical position can be seen as blurred and greasy image (Figure 3).

Figure 2. Irregular scanner positioning in bucco-oral and mesio-distal direction.
Slika 2. Loše pozicioniranje skenera u bukooralnom i meziodistalnom pravcu.

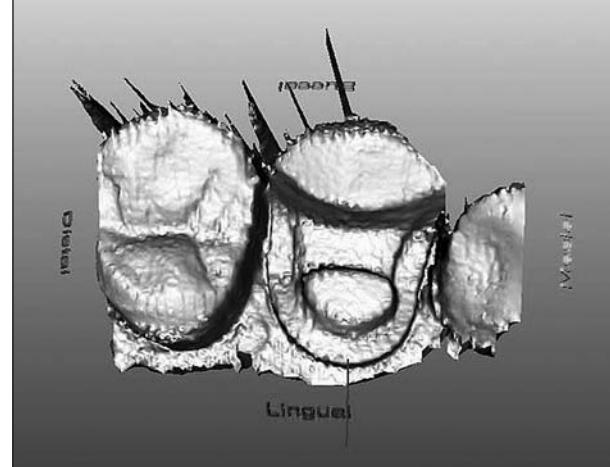
Figure 3. Irregular scanner positioning in occluso-gingival direction.
Slika 3. Loše pozicioniranje skenera u okluzogingivalnom smeru.

Idealna pozicija skenera u odnosu na objekat snimanja je takva da ugao skenera u meziostalnom pravcu bude 30 stepeni u odnosu na distalnu tačku oslonca. U bukoornom smeru optimalan je ugao od 90 stepeni u odnosu na objekat, koji treba da je projektovan u centru sočiva kamere. U okluzogingivalnom pravcu rastojanje od najgingivalnije tačke objekta koji se snima i sočiva skenera ne bi trebalo da bude veće od 15 mm. Veća odstupanja od ovih vrednosti dovode do neodgovarajućih formi virtuelnog modela, iskrivljenih površina i netačnih krajnjih dimenzija nadoknade i samim tim pogrešnim matematičkim proračunima centralnog modula (Slika 2). Ovu vrstu grešaka najčešće nije teško prepoznati, jer su određeni delovi slike u senci ili su maskirani okolnim strukturama. Greške u vertikalnom pozicioniranju se ogledaju u zamućenosti i deformitostima slike (Slika 3).

easy to position in conditions below the average size of anatomical structures. Also, there are difficulties during performing impression of third molars, or when distal agonist is missing. In these cases, there is no firm support for the camera and it is leaned on the soft tissues. When it happens, after tooth preparation, patient should be relaxed and explained the procedure while the therapist should ensure the fixation of the hand holding scanner similarly to work with high speed handpiece. Therapist must follow the image on the monitor, not the position of the camera in the mouth.

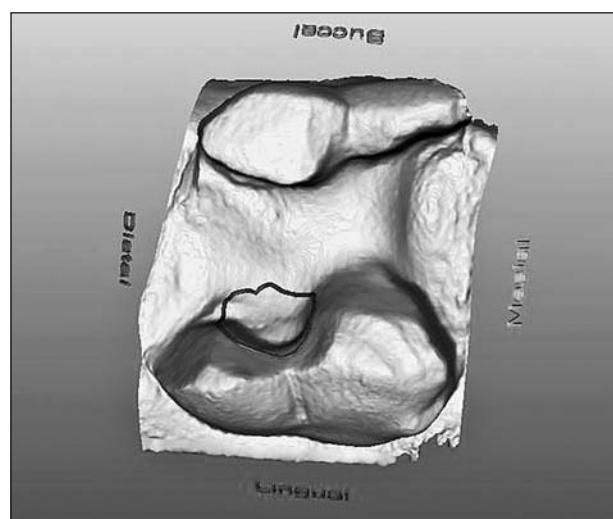
Figure 4. Irregular MOD cavity preparation on the first molar.
Slika 4. Nepravilno prepariran kavitet tipa MOD na prvom molaru.

Figure 4 shows almost all irregularities made by inadequate tooth preparation. A bordered box is subverted region. Similar region also exists on the buccodistal surface close to the pulpal wall. Mesial surface of the buccal wall is too thin to endure occlusal forces characteristic for this region. Enamel edges are beveled somewhere. Scanner can not "see" subverted surfaces and in the case of their existence after cementation of dental restoration, "dead" space suitable for the recurrent caries will occur and the possibility for loosening the crown will be higher (cement layer thicker than 10 microns can not keep dental restoration in a place) [9]. For this reasons, recommendation is to prepare walls under 90 degrees. Enamel edges should not be beveled, otherwise there is a high probability for marginal leakage of the onlay (gap greater than 50 microns). Also, with beveled edges it is not possible to determine the margins of the future inlay on a virtual model.

Na slici 4 su prikazane skoro sve nepravilnosti koje se mogu napraviti neadekvatnom preparacijom. Ovičeno polje je podminirana regija. Podminiranost postoji i na bukodistalnoj površini prema pulparnom zidu. Mezijalna površina bukalnog zida je isuviše tanka da bi izdržala buduće okluzalne sile tipične za tu regiju. Rubovi gledi su na pojedinim mestima zakošeni. Podminirane površine skenera "ne vidi", pa bi u slučaju njihovog postojanja po fiksiranju nadoknade ostao "mrtav" prostor pogodan za pojavu sekundarnog karijesa, odnosno mogućnost da se ovakva nadoknada rascementira (zbog neadekvatne debeline sloja cementa koji ne bi smeо biti deblji od 10 mikrona) [9]. Zbog toga se preporučuje da ugao između zidova preparacije bude 90 stepeni. Rubove gledi ne treba zakošavati, jer u suprotnom postoji velika verovatnoća da rubno zaptivanje inleja bude nezadovoljavajuće (zazor veći od 50 mikrona). Takođe, kod zaobljenih rubova kavite nije moguće precizno odrediti granice budućeg inleja na virtuelnom modelu.

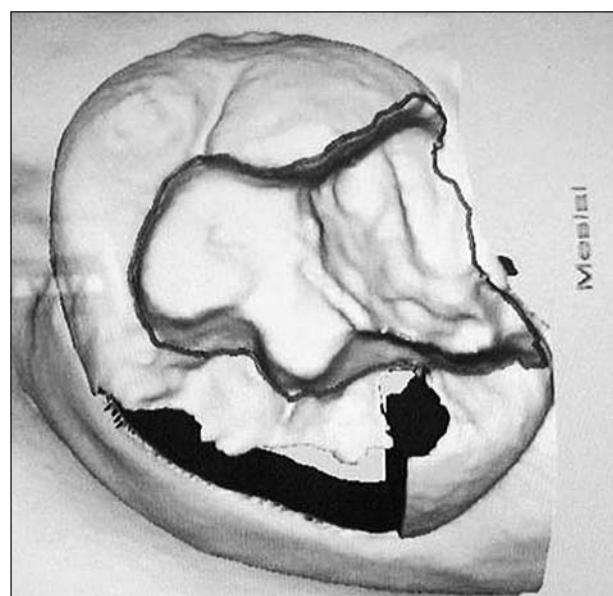
Figure 5. Incomplete tooth picture as result of missing matting powder in some parts.
Slika 5. Nepotpuna slika zuba nastala usled nedovoljnog nanošenja matirajućeg praha.

Figure 5 shows the appearance of the area where the scanning powder is not evenly distributed. There are visible defects on the image because the computer can not mathematically process and project the surface on which powder is not applied. Figure 6 shows the error in the infliction of great amounts of powder in the proximal cavity and its edges. Demarcation is unclear and lifted at the end. When gently curved transition between walls at the bottom of

Na slici 5 je prikazan izgled skeninga površine na kojoj nije naneseno dovoljno praha. Uočljiva su oštećenja slike jer kompjuter ne može matematički da obradi i projektuje površinu na koju prah nije nanet. Na slici 6 je prikazana greška u nanošenju veće količine praha na aproksimalni kavitet i na njegov rub. Demarkacija je nejasna i s uzdignutim krajem. Kada je uočljiv blag i zaobljen prelaz zidova na dno kavite, onda je greška u predugom nanošenju praha na tom mestu. U velikom broju slučajeva ovaj problem se može prevazići lokalnim čišćenjem praha i ponovnim matiranjem. Na slikama 7a i 7b se takođe može uočiti prevelika količina praha nanesenog na dno kavite, ali je naranči praha grudvast i lokalizovan. Ovakva slika se dobija kada postoji problem s aparaturom za nanošenje praha. Potrebno je zato lagano protresti bočicu s prahom i ponoviti postupak matiranja. Ako se problem ponovi, onda je na neki način došlo do unošenja vlage u kontejner s prahom za matiranje, pa ga treba promeniti. Ovaj nedostatak je pokušala da prevaziđe Američka firma D4D sa svojim modelom E4D, koji je baziran na kamери sa konusnim laserskim zrakom. Prednost ovakvog sistema je u tome što je nanošenje praha titanijum-oksida nepotrebno, ali je zbog divergentnog smera prostiranja zraka neophodno sačiniti najmanje tri slike za jednu preparaciju, koju kompjuter matematičkim proračunavanjem spaja u jednu [10].

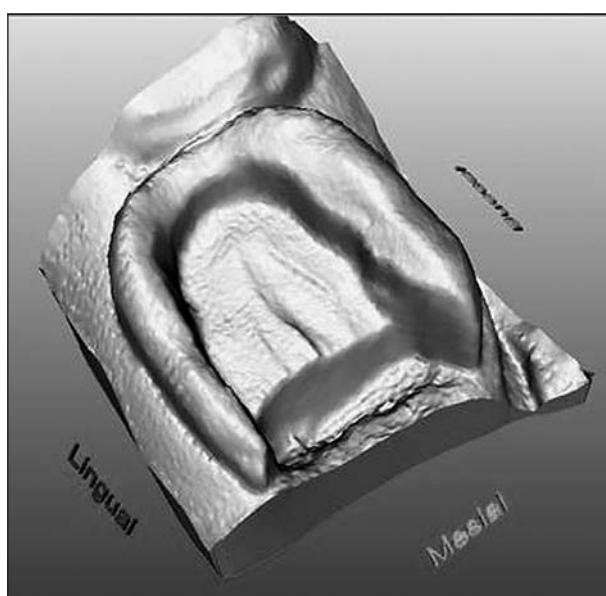
Figure 6. Greater amount of powder on the bottom of proximal cavity and demarcation.
Slika 6. Višak praha za matiranje nanesen na dno proksimalnog kaviteta i demarkaciju kaviteta.

the cavity is seen, then the error is excessive powder coating. In many cases this problem can be overcome by local powder removing and reapplying. In figure 7a and 7b great amount of powder inflicted on the bottom of the cavity, localized and clogged, can be observed. If this happens, there is a problem with the equipment for powder coating. It is important to shake the bottle with the powder gently and to repeat the procedure. If the problem persists then it is possible that moisture entered the container with the powder and it should be changed. American company D4D with E4D model, based on the camera with the conical laser beam tried to avoid this inconvenience. The advantage of this system is that titanium oxide powder coating is unnecessary, but because of divergent beam, a minimum of three scans for one preparation, combined by the computer later is needed [10].

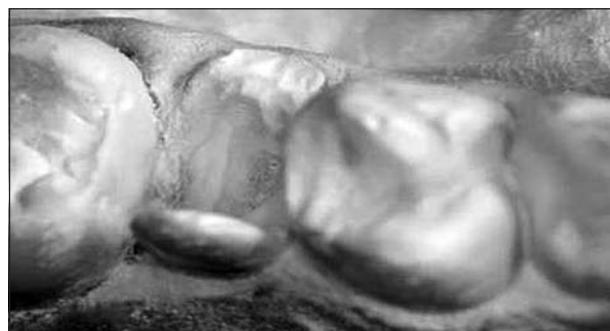
Figure 7a. Irregular powder arrangement.

Slika 7a. Nepravilno nanesen prah za matiranje.

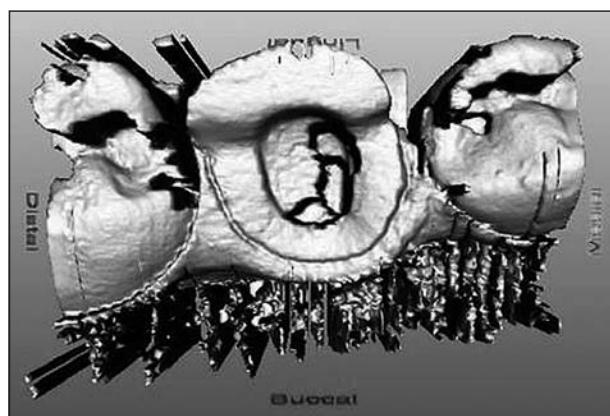
Figure 7b. Excessive amount of the powder on the bottom of the cavity.

Slika 7b. Višak praha na dnu kaviteta.

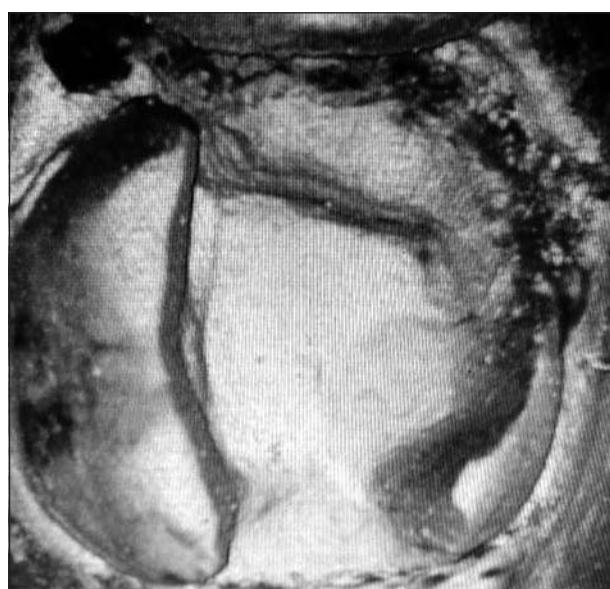
Figure 8. The first molar scanning, floss remnants on the mesial part of the tooth and fluid in buccal region.

Slika 8. Skening prvog molara na kojem se mogu uočiti artefakti konca na mezijalnoj strani zuba i tečnost u bukalnoj regiji.

Considering that the base for optical impression is visibility of the demarcation, preparation of the gingival sulcus is a very sensitive stage. When demarcation of the cavity is supragingival, just rinsing with water and drying is sufficient. Gingival or subgingival demarcation should be prepared to be visible. Figure 4 shows the demarcation of the preparation on the proximal cavities unclear or completely invisible. Use of liquids and threads for gingival retraction is therefore acceptable procedure during optical impression. The thread artifacts that remain in the sulcus can make image blurred and their removal is mandatory prior to impression. In Figure 8, the thread masks demarcation on the mesial part of tooth. In buccal region of the sulcus, the fluid is present in the scanned region (absence of dry working field).

It is possible to use other methods for gingival sulcus impression instead of thread. Application of chemical, mechanical or combined devices such as Expasyl® (Pierre Rolland) and Magic® Foam (Colten) give good results. After their careful removal, there are no side effects in the region of gingival sulcus (the scanning artifacts or false images). When is not possible to ensure the complete visibility of subgingival demarcation, soft laser or electrical cutter can be used.
