## Fracture Resistance and Failure Pattern of Endodontically Treated Teeth Restored with Computer-aided Design/Computer-aided Manufacturing Post and Cores: A Pilot Study

<sup>1</sup>Rita Eid, <sup>2</sup>Jelena Juloski, <sup>3</sup>Hani Ounsi, <sup>4</sup>Munir Silwaidi, <sup>5</sup>Marco Ferrari, <sup>6</sup>Ziad Salameh

**How to cite this article:** Eid R, Juloski J, Ounsi H, Silwaidi M, Ferrari M, Salameh Z. Fracture Resistance and Failure Pattern of Endodontically Treated Teeth Restored with Computer-aided Design/Computer-aided Manufacturing Post and Cores: A Pilot Study. J Contemp Dent Pract 2019;20(1):56-63.

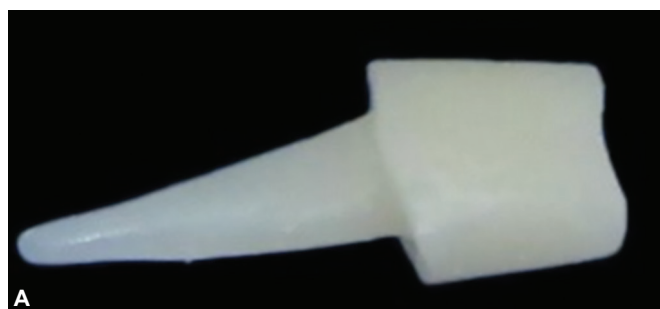
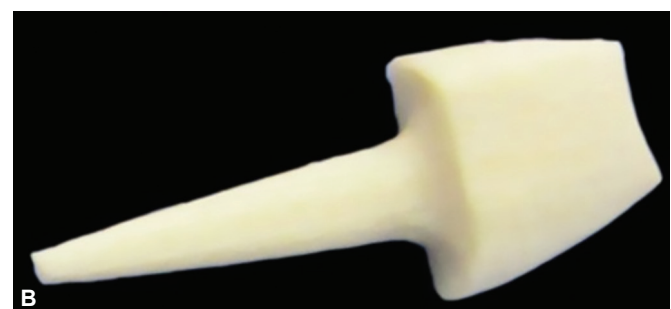
**Figs 1A and B :** (A) Representative figure custom milled post and core Trilor; (B) Representative figure custom milled post and core Ambarino

For groups 2 (BLC) and 3 (AMC) all prepared canal spaces were lubricated with a minimum die lubricant (Picosep, Renfert, Hilzingen, Germany). Direct resin patterns were fabricated (Pattern Resin, GC America, Alsip IL, USA) maintaining an equal length of 4 mm above the ferrule with a 30-degree angulation of the buccal cusp slope to the long axis of the tooth verified on the dental surveyor. The resin patterns were sprayed with a scan powder (IPS Contrast Spray; Ivoclar Vivadent, Schaan, Liechtenstein) and scanned with a lab scanner (Imetric 1041, Courtenay, Switzerland). After scanning, digitized data collected were transmitted to a special digital software (Exocad dental CAD, Exocad GmbH, Darmstadt, Germany) where a design was conceived for

each post, after what a CAM software (WorkNC Dental, Frankfurt, Germany) was used to develop the milling sequence for each of the materials used. The posts were undersized by 80 microns to compensate for the thickness of the scanning spray and the luting resin cement. The customized posts and cores (groups 2 and 3) were milled using a 5-axes milling machine (Datron D5, Datron AG, Darmstadt, Germany). The machine movement was adjusted by decreasing the Z step and lateral step over speed to reduce lateral bending movement leading to the fracture of the post on its apical end. Burs of 2.5 mm, 1 mm and 0.6 mm were used (Datron AG). In group 2 (BLC), blocks were used since the unidirectional fibers responsible of stress dissipation are concentrated in the long axis of the blocks (Fig. 1A) and posts were silanized (Rely X ceramic primer, 3M ESPE) as per manufacturer recommendations. As for group 3 (AMC) posts were dry milled from disks (Fig. 1B), sand blasted with 50 µ aluminum oxide particles and silanized (Rely X ceramic primer, 3M ESPE) following the manufacturer recommendations. All the post and cores (group 2-RXP and 3-AMC) were cemented in their respective canal spaces previously irrigated with distilled water and dried with paper points using a self-adhesive resin cement (Rely-X U200 Automix, 3M-ESPE, Seefeld, Germany). Elongation tips were used to place the cement in the canal to avoid air bubbles. Excess cement was removed after light polymerization (Elipar S10 LED curing light, 3M ESPE) for 40 seconds on each axial wall of the tooth.

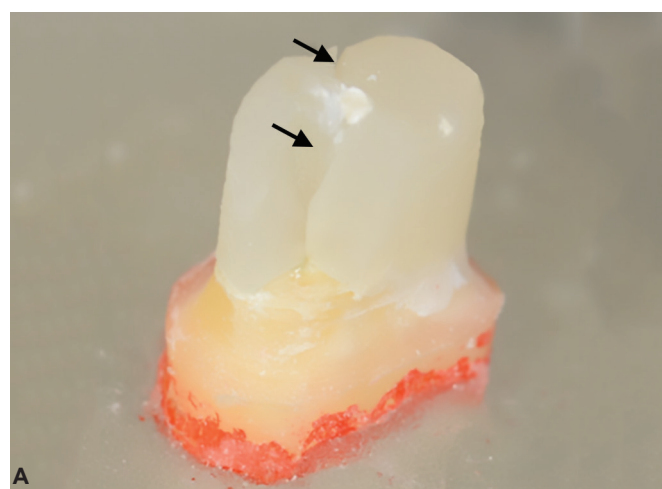
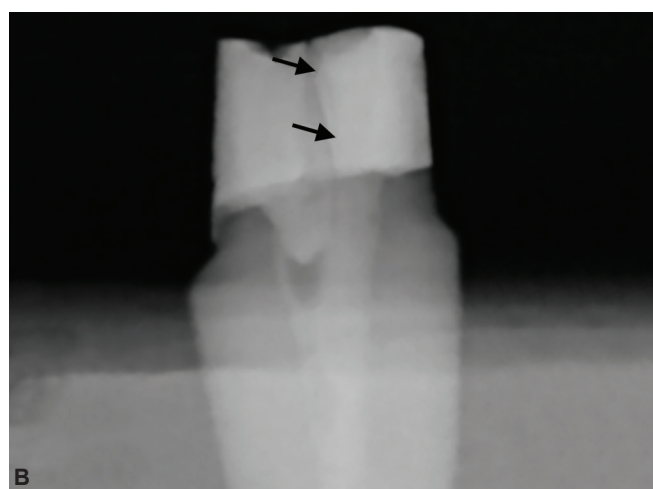
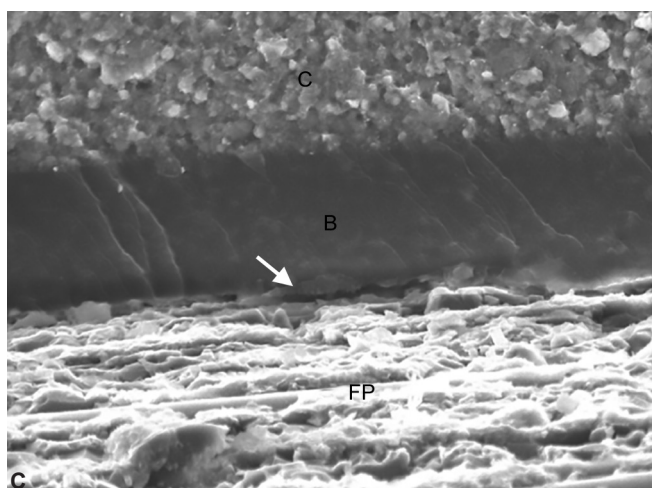
**Figs 2A to C:** (A) Representative photograph showing a crack in the core (arrow) and between the post and the core build up (arrow); (B) Radiograph displaying the extent of the crack (arrow); (C): SEM micrograph revealing failure at the interface between the bonding and the fiber post surface (C: Composite; B: Bonding; FP: Fiber post).

test group is listed in Table 3. Regarding group 1 (RXP) all specimens displayed mixed failure patterns and partial core debonding and core fracture (Figs 2A and B) with no fracture of the tooth, the SEM of the fractured specimens showed a failure at the interface between the post surface and the bonding agent used (Fig. 2C). As for group 2 (BLC) posts and cores, the mode of failure was cohesive within the core: a crack in the coronal part was observed visually and radiographically without any damage to the tooth structure (Figs 3A and B). The SEM revealed rupture of fibers by the failure of the interface between the fiber and the surrounding matrix (Fig. 3C). Group 3

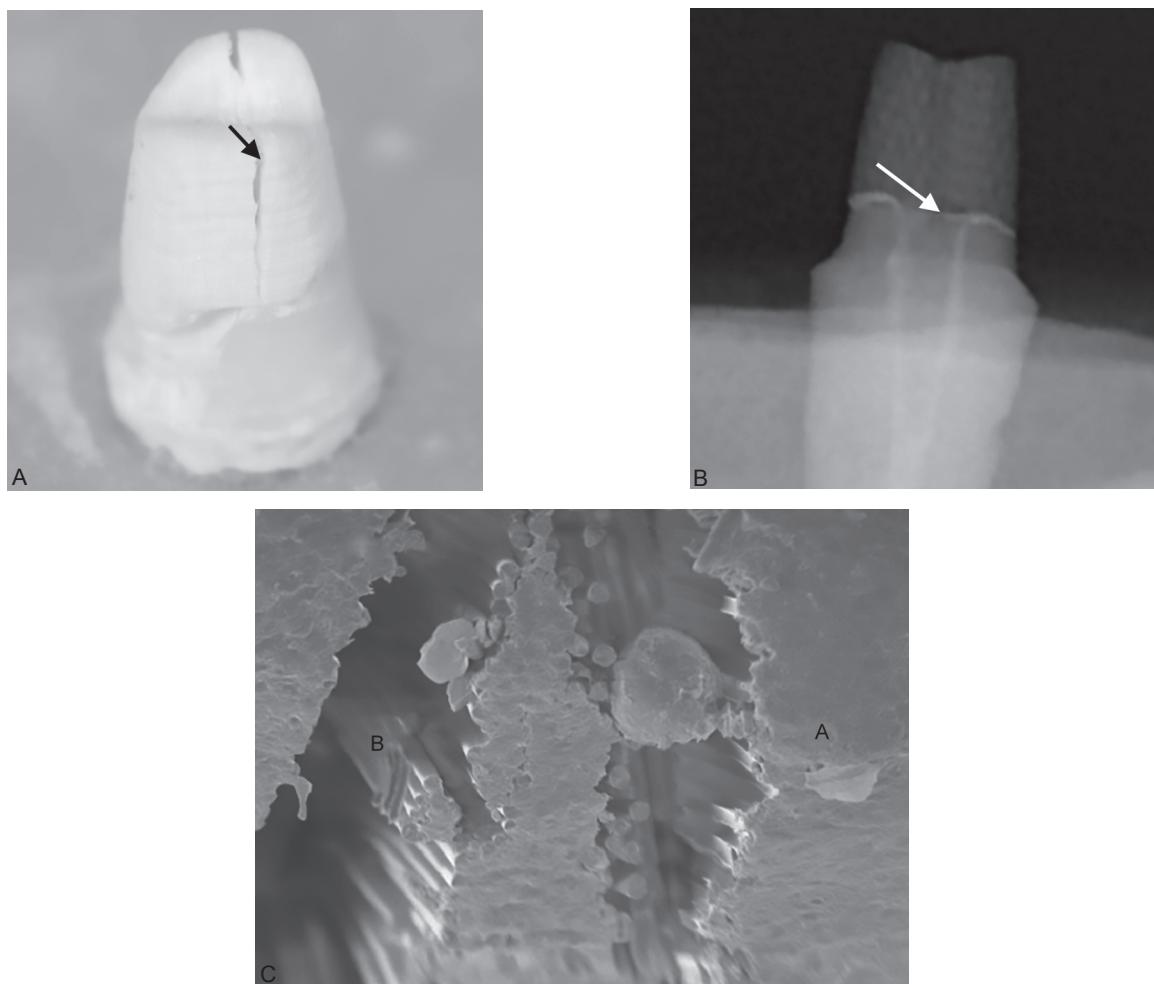
**Figs 3A to C:** (A) Representative photograph showing a crack in the core (arrow); (B): Radiograph displaying the extent of the crack (arrow); (C): SEM micrograph revealing a rupture of fibers by failure of the interface between the fiber and the surrounding matrix (A: Occlusal surface; B: Rupture of fibers).

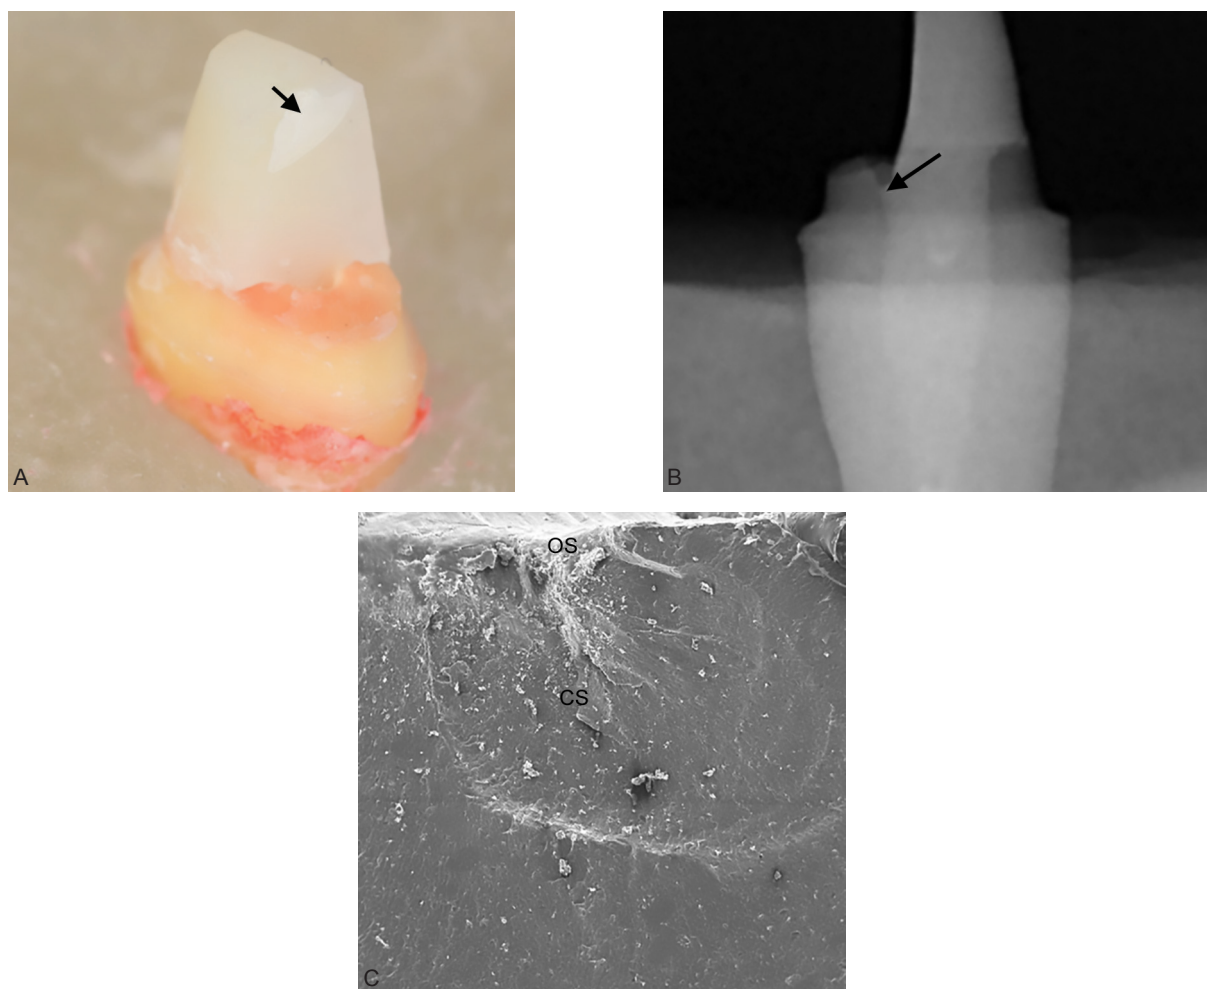
**Figs 4A to C:** (A) Representative photograph displaying the fracture in the core (arrow); (B) Radiograph displaying the extent of the fracture in the core (arrow); (C) SEM micrograph revealing a radial crack located below the surface point of load application on the occlusal surface of the post that fanned out as it propagated apically (OS: Occlusal surface, CS: Crack surface).

(AMC) showed a cohesive fracture of the core starting from the point of the force application was observed for all samples, minimal fracture of the tooth was observed in two samples above the CEJ (Figs 4A and B). No tooth fracture or post fracture were reported in any of the specimens. SEM revealed a radial crack located below the surface point of load application on the occlusal surface of the post that fanned out as it propagated apically (Fig. 4C).
