ORIGINAL ARTICLE / ОРИГИНАЛНИ РАД

Effects of sodium hypochlorite on corrosion of the rotary nickel-titanium endodontic instruments – SEM analysis

Milica Jovanović-Medojević¹, Jelena Nešković¹, Marijana Popović-Bajić¹, Đorđe Stratimirović², Slavoljub Živković¹

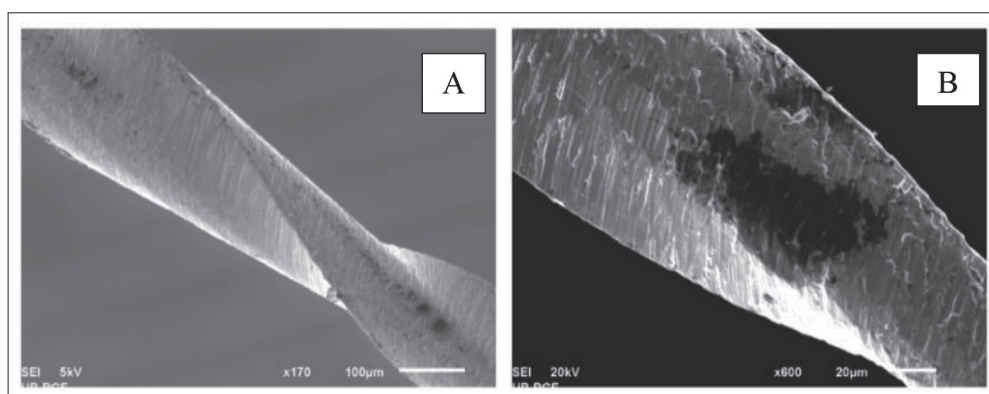
Figure 1. Spin echo image of the new Mtwo instrument (10/0.4): A – surface of the middle third on which the presence of corrosion is observed (170 ×); B – detail from the previous image at higher magnification (600 ×)

In new Ni-Ti instruments, corrosion was observed in 5.5% of K3 system instruments (apical and middle segment), in 5.5% of Mtwo instruments (apical third) (Figure 1) and in 11.1% of ProTaper Universal system instruments (apical and middle third). Corrosion was not observed on the new sets of HyFlex and BioRaCe instruments (Table 2).

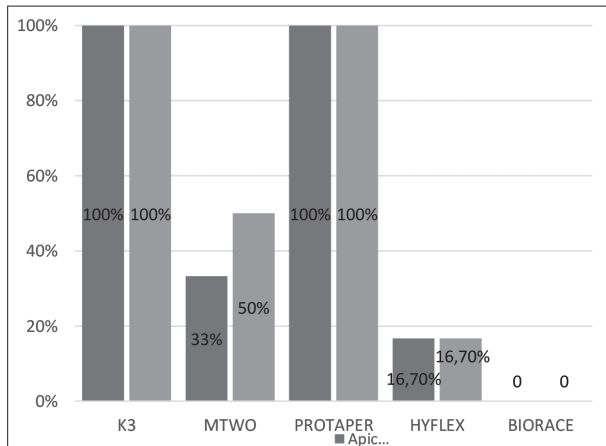
Figure 2. Prevalence of corrosion on Ni-Ti instruments after instrumentation of disinfection and sterilization in the canals of the first group; letters (a or b) indicate no statistically differences ($p > 0.05$)

In the first group, corrosion was observed on all instruments K3, ProTaper Universal and HyFlex systems (apical and middle third), and in Mtwo systems on 16.7% of instruments (apical and middle third). Corrosion was not observed in BioRaCe instruments. A statistically significant difference was observed between the K3, ProTaper Universal and HyFlex systems compared to the Mtwo and BioRaCe systems of the first experimental group ($p < 0.05$) (Table 3, Figure 2).

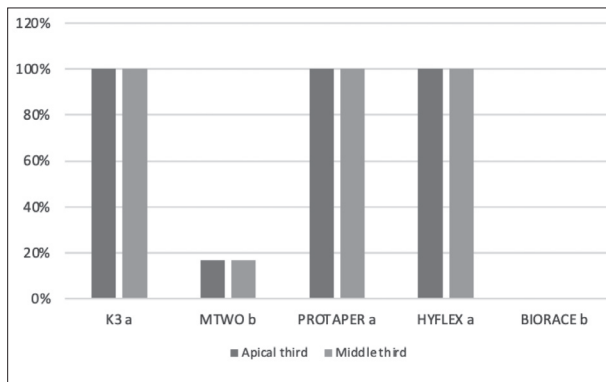
Figure 3. Corrosion prevalence on Ni-Ti instruments after instrumentation, disinfection and sterilization in the channels of the second group; letters (a or b) indicate no statistically differences ($p > 0.05$)

In the second experimental group, corrosion was observed on all analyzed Ni-Ti instruments K3 (Figure 3) and ProTaper Universal system (apical and middle third), in HyFlex set on 16.7% of instruments (apical and middle third), and in Mtwo set instruments, to 33.3% of instruments in the apical segment and 50% in the middle third. No corrosion was observed on BioRaCe instruments. A statistically significant difference was observed between K3 and ProTaper Universal systems compared to Mtwo, HyFlex and BioRaCe system ($p < 0.05$) (Table 3, Figure 4).

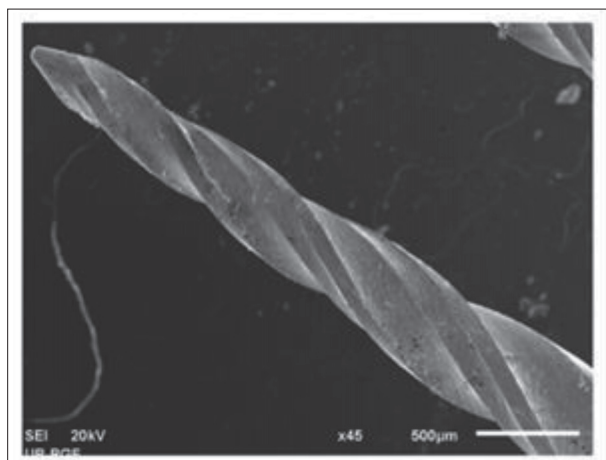
Figure 4. Spin echo image K3 instrument (25–0.08), second experimental group (corrosion on the apical third) (45 ×)

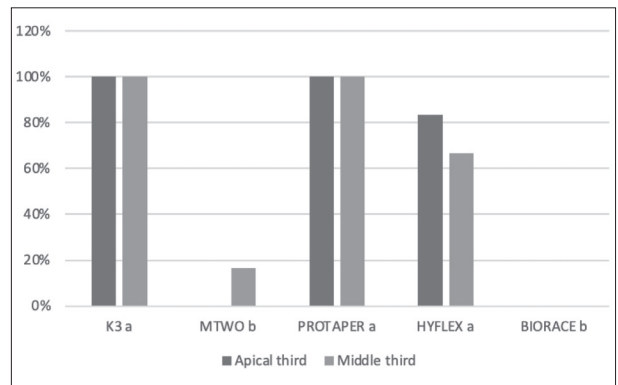
Figure 5. Prevalence of corrosion by Ni-Ti instruments after instrumentation, disinfection and sterilization of third group; letters (a or b) indicate no statistically differences ($p > 0.05$)

In the third experimental group, corrosion was observed on all analyzed Ni-Ti instruments K3 and ProTaper Universal system (apical and middle third), in 83.3% of HyFlex set instruments in the apical and 66.7% in the

middle segment (Figure 5). In the Mtwo set, corrosion was observed only in the middle third in 16.7% of the instruments. A statistically significant difference in the occurrence of corrosion was observed between K3, ProTaper Universal and HyFlex systems in relation to Mtwo and BioRaCe system ($p < 0.05$) (Table 3, Figure 6).

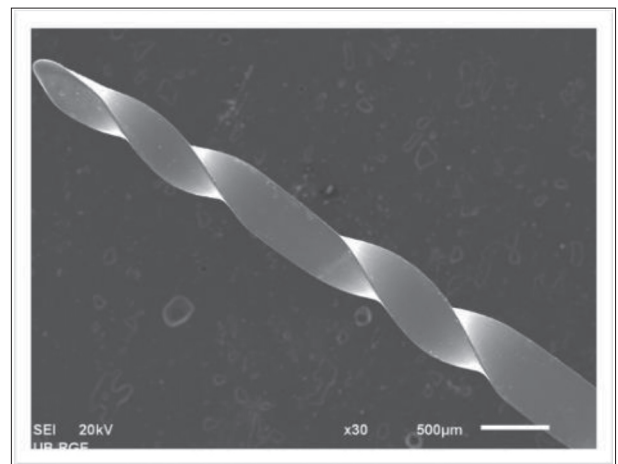
Figure 6. Spin echo image BioRaCe instrument no. 4 without incorporation and corrosion (30 ×)

The BioRaCe system of Ni-Ti rotating instruments is subjected to an electropolishing procedure during final processing, which reduces the possibility of surface irregularities and increases resistance to corrosion and cyclic fatigue, which is also in accordance with the results of this study [2, 9]. Shahi et al. [30] hypothesized that corrosion occurs due to manufacturing defects on the surface of
