# Sem analysis of working surface in new manual endodontic instruments

**Introduction** The aim of this study was to analyze working surfaces of new hand endodontic instruments and to check possible existence of dirt or defects on working surface that resulted from manufacturing process using SEM.

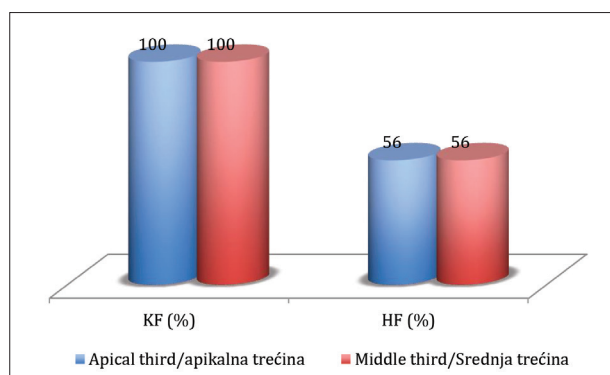
Debris was noticed on all KF instruments (100% apical and middle third) and half of the HF instruments (56% apical and middle third) (Table 3, Graph 1, Figure 4 and 5). After the comparison of debris on different hand instruments (KF and HF), statistically significant difference was noted ( $p = 0.0029$  in apical and  $p = 0.0029$  in middle third).

**Graph 1.** Presence of debris on working surface of tested instruments

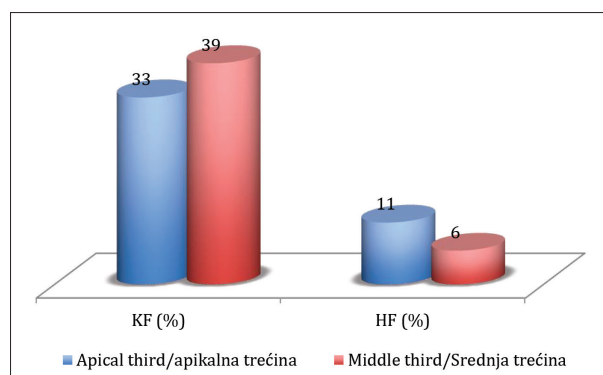
The presence of pitting was noted in apical and middle third of KF instruments (33% apical and 39%

**Graph 2.** The presence of pitting on working surface of tested instruments
