# Endodontic Treatment of Lower Anterior Teeth with Multiple Canals

**Introduction** Knowledge of root canal morphology is one of the main prerequisites for successful endodontic treatment. We present the case of a patient with multiple canals in lower anterior teeth which were treated endodontically.

**Case Report** To a 45-year-old patient endodontic treatment was applied on lower left lateral incisor, lower right central and lateral incisor and lower right canine. These teeth were previously prepared for prosthetic crowns. All involved teeth had two canals which were not visible on the primary radiographs. Gracility of remaining tooth structure and canals and the presence of two canals in each tooth required additional radiographs for verification of multiple canals. Careful biomechanical instrumentation and irrigation with use of lubrication due to narrow canals was performed. The canals were obturated with gutta-percha using lateral compaction technique and Acroseal (Septodont) paste. On the control checkup after eight months, the patient was asymptomatic, while clinical finding was normal.

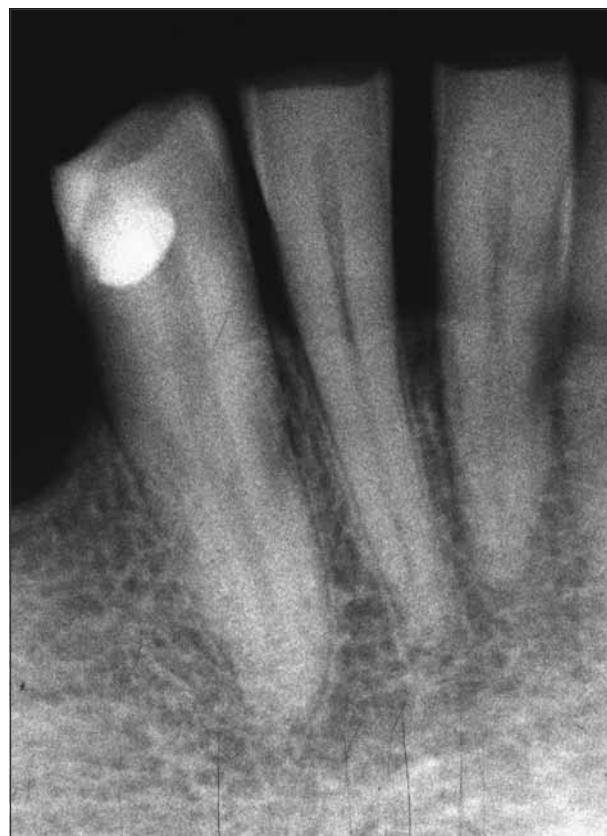
**Figure 1.** One canal in the tooth 32 as shown on preoperative radiograph

A 45-year-old woman showed up at the Clinic for restorative Dentistry and endodontics, School of Dentistry in Belgrade for endodontic treatment of the lower anterior teeth, previously prepared for prosthetic crowns. Lower left lateral incisor, lower right central and lateral incisor and lower right canine were proposed for endodontic treatment. Teeth were vital and percussion test was negative. Analysis of preoperative diagnostic radiograph revealed one canal in the lower left lateral incisor (Figure 1), one canal in right central and lateral incisor and two separate canals in lower right canine were clearly visible on the radiograph (Figure 2).

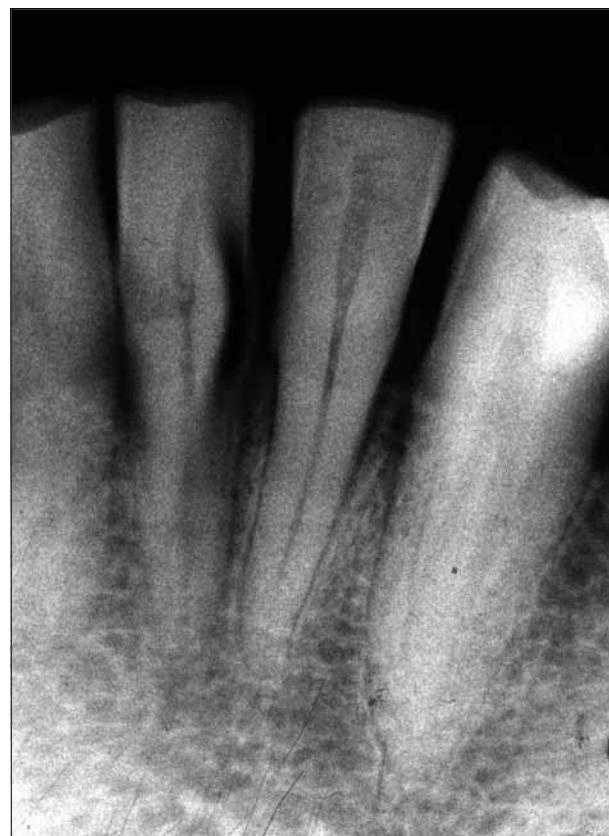
**Figure 2.** One root canal in the teeth 41, 42 and two root canals in the tooth 43 (preoperative radiograph)

Three lower right anterior teeth were endodontically treated in the next appointment. Preoperative diagnostic images of the lower right central and lateral incisor showed that both of them had one canal, while in the right canine two separate canals were visible (Figure 2). Having experience with multiple canals in the lower left lateral incisor and visible two canals in the lower right canine, there was an assumption that all three teeth may have two canals. Endodontic treatment was conducted as described for the lower left lateral incisor. By inserting thin instruments in the canals, two canals were validated in the three lower right anterior teeth (Figure 5). Canals were instrumented, irrigated and obturated with gutta-percha using lateral compaction technique and Acroseal paste. Radiography was performed from two different angles to be able to register two canals (Figures 6 and 7). Control checkup after eight months was performed and patient had no subjective problems.

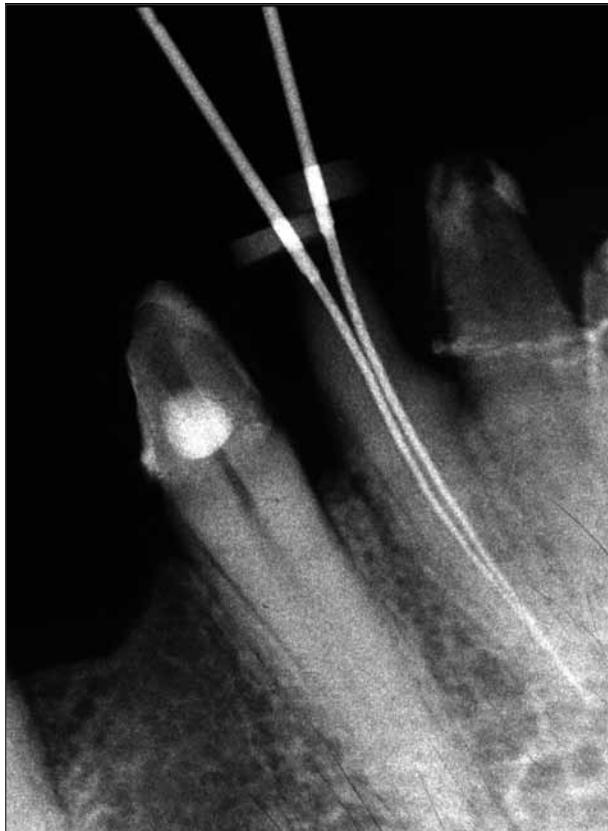
**Figure 3.** Endodontic files placed in two canals

radiograph. By careful exploration, lingual entrance was detected, two instruments were placed in the canals and another radiograph was taken (Figure 3). The entrance of the canal was instrumented by Gates Glidden bur #2. Working length was determined using apex locator Root ZX (Morita, Europe GmbH, Frankfurt, Germany). The canals were instrumented using flexible hand canal instruments and Canal+ (Septodont) as lubricant. Step back technique and irrigation with 0.5% NaOCl solution were applied for canal instrumentation. The canals were obturated using Acroseal (Septodont) paste and gutta-percha and additional radiograph was taken (Figure 4).

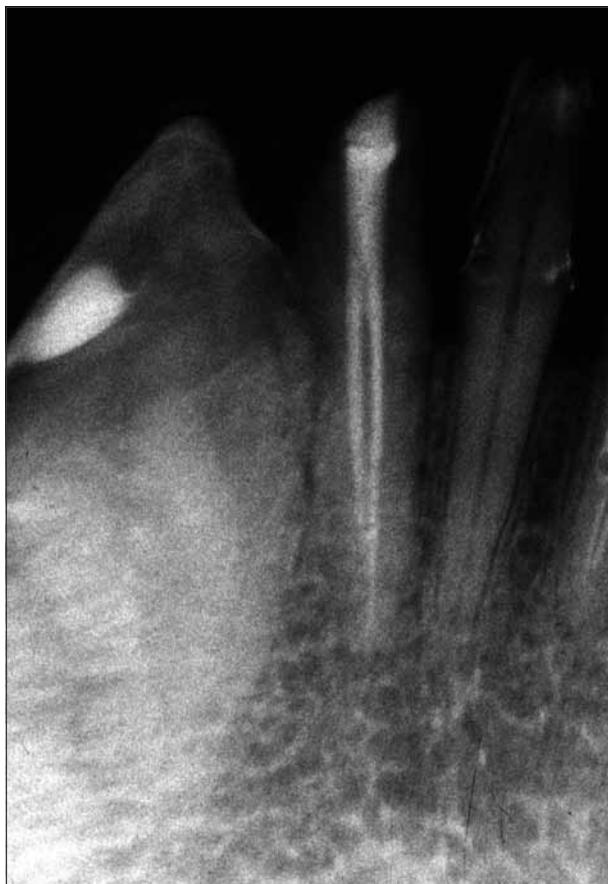
**Figure 4.** Final obturation of two root canals

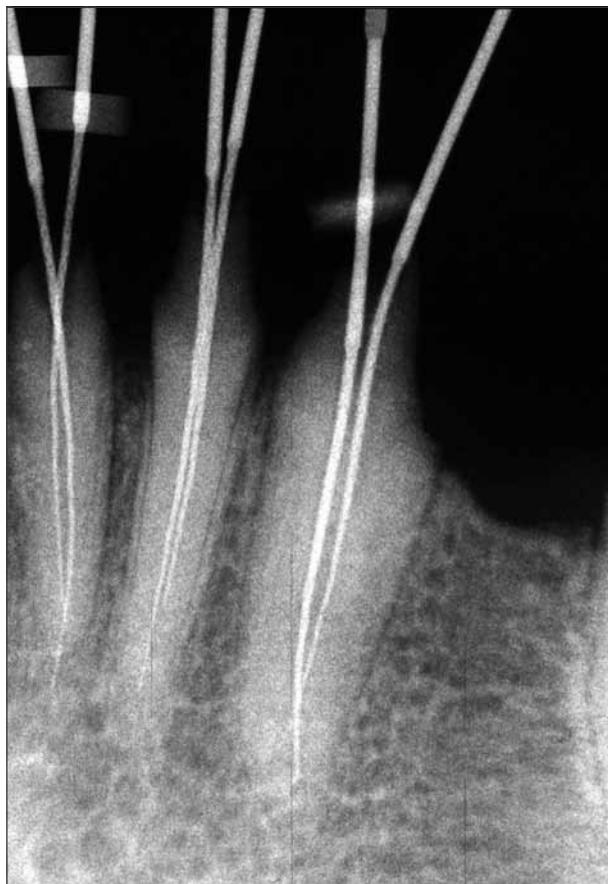
**Figure 5.** Endodontic files placed in two canals of the teeth 41, 42 and 43

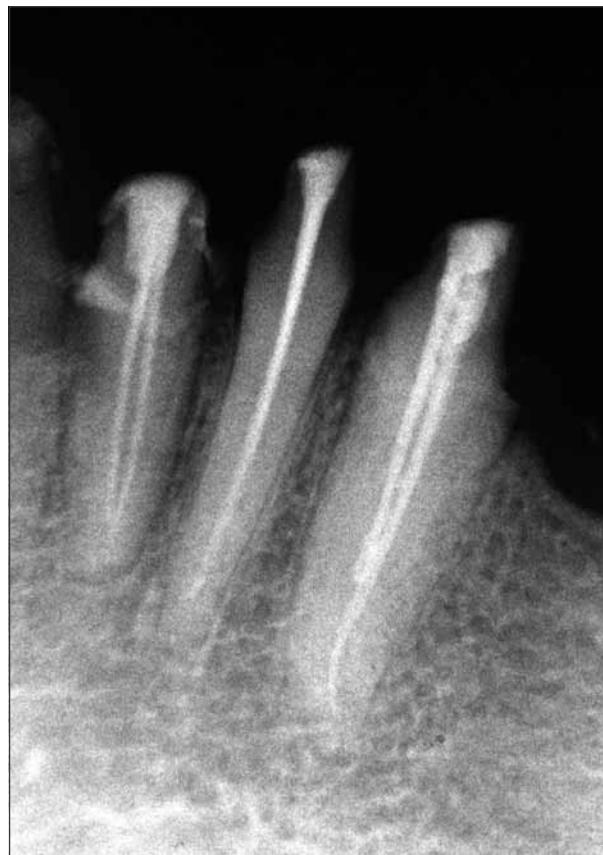
**Figure 6.** Final obturation of two canals in the lower right central and lateral incisors

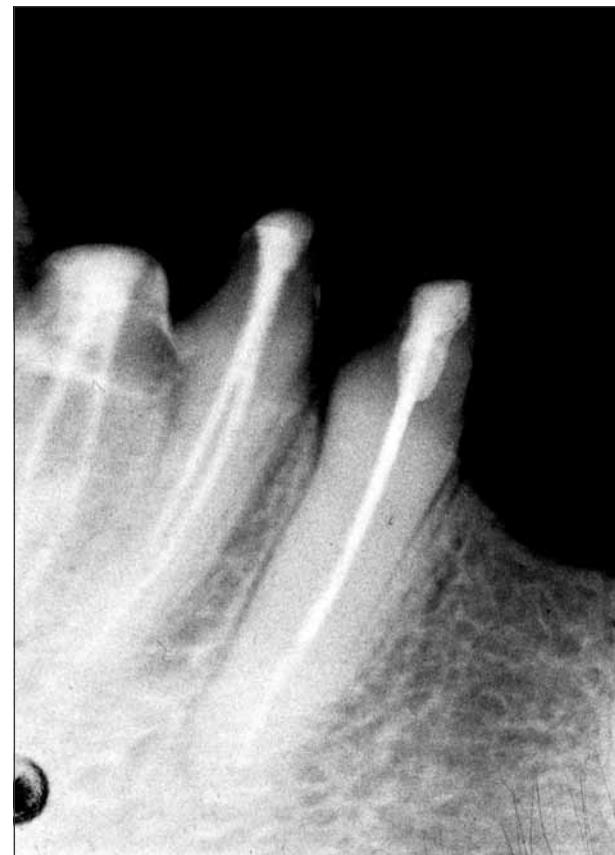
**Figure 7.** Final obturation of the lower right canine
